Minimizing corrosion risks of low load operation

CCGT plant, UK

Low load operation led to significant Flow Accelerated Corrosion (FAC) damage in the high pressure evaporator circuit with potential lengthy outage for replacement.

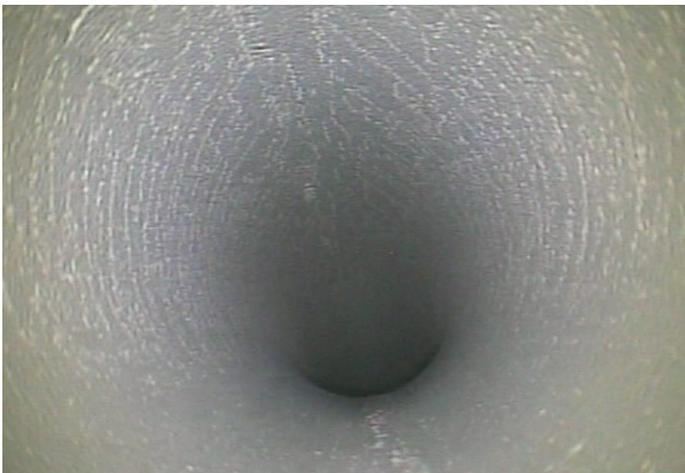
In line with market demands for flexible operation, our client's 1200 MW CCGT plant operates for significant periods at low load. Therefore HP piping in the heat recovery steam generator is now subject to lower temperatures in a risk range for FAC.

Significant FAC was discovered in the HP evaporator circuit, presenting challenges to replace the riser pipes as quickly as possible, ensure the safety of other parts of the circuit and protect against future corrosion.

Flow Accelerated Corrosion identified in a HP riser

We advised replacing the carbon steel piping with more resistant P22 chromium alloy and swiftly verified materials as supplies were identified.

We also advised on a change to the cycle chemistry regime. Repeat inspections showed this significantly reduced further corrosion.
