Minimizing corrosion risks of low load operation

CCGT plant, UK

Low load operation led to significant Flow Accelerated Corrosion (FAC) damage in the high pressure evaporator circuit with potential lengthy outage for replacement.

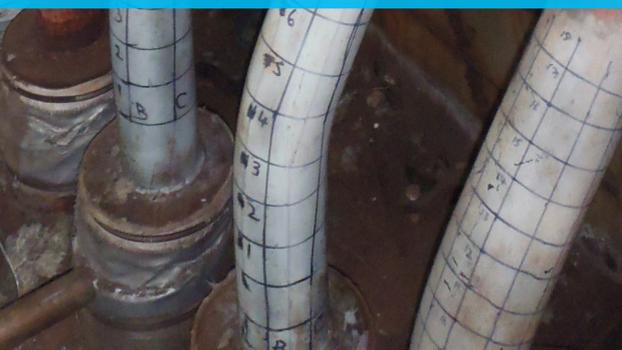
Significant FAC was discovered in the HP evaporator circuit, presenting challenges to replace the riser pipes as quickly as possible, ensure the safety of other parts of the circuit and protect against future corrosion.

Flow Accelerated Corrosion identified in a HP riser

FAC is a widely recognised risk in low and intermediate pressure piping. In this case, we found corrosion in the HP evaporator circuit which could have resulted in the failure of high energy pipework and worked with the client to prevent this through a combination of chemistry changes, condition monitoring and replacement works at planned outages.

Having identified the corrosion, we ensured our client could replace the affected pipework with material of greater corrosion-resistance in a manner that had least impact on plant availability.
